**Flood Control Project Maintenance  
Levee Inspections****LMA District Cover Sheet****Spring 2011 Levee Inspection Results****Reclamation District No. 0501 Ryer Island**

**Levee Inspection Report By Mile - Spring 2011**

**Reclamation District No. 0501 Ryer Island**

Waterway							Bank	Unit Miles	Inspection Start/End	Inspector
Unit No. 01 Steamboat Slough							Right	6.76	04/19/2011 04/19/2011	Herman Phillips
LMR No.	Levee Mile		Category	Item	Location *	Rating **	Action/Comment	GPS Latitude/Longitude		Issue No.
	Start	End						Start	End	Photo
1	0.00	0.00	Earthen Levee	Vegetation	LS	M	Control annual grass and weeds on the levee slopes and easements.	38.230288 ° 38.230288 °	-121.603781 ° -121.603781 °	1 Y
2	0.03	0.06	Earthen Levee	Trim / Thin Trees	LS	M	Thin trees to allow visibility of the ground and room to flood fight.	38.254011 ° -121.601810 °	38.253547 ° -121.602264 °	2
3	0.04	0.07	Earthen Levee	Vegetation	WS	M	Remove the wild growth other than native grasses from the levee slopes.	38.230288 ° 38.253518 °	-121.603781 ° -121.602252 °	4
4	0.05	0.06	Earthen Levee	Trim / Thin Trees	LS	M	Trim trees to at least five feet above ground level.	38.253710 ° -121.602098 °	38.253608 ° -12

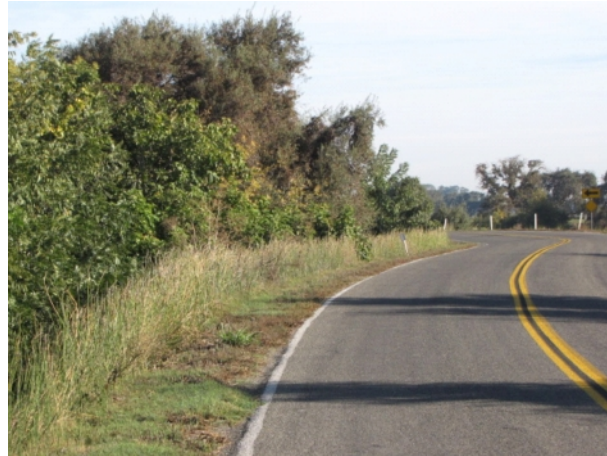
Levee Mile Report Line	1
Start Levee Mile	0.00
End Levee Mile	0.00
Location	Land Side
Category	Earthen Levee
Item	Vegetation

Rd 501 Levee mile 0.00 land side looking downstream from Unit 1, wild growth of walnut trees on slope. Photo taken 11-03-2010

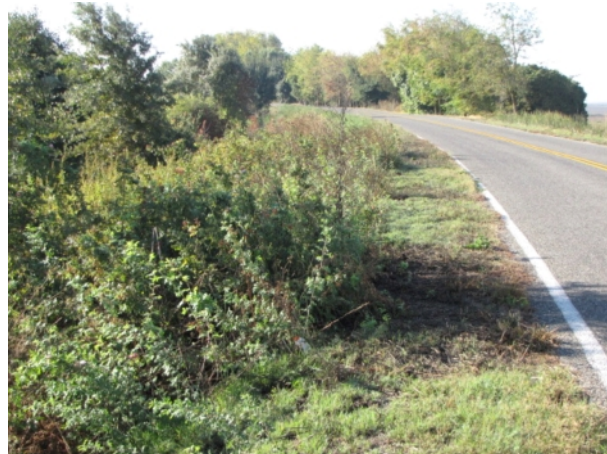
Levee Mile Report Line	1
Start Levee Mile	0.00
End Levee Mile	0.00
Location	Land Side
Category	Earthen Levee
Item	Vegetation

RD 501 Levee mile 0.00 looking downstream from water side. View of wild berries on slope and shoulder. Photo taken 11-03-2010

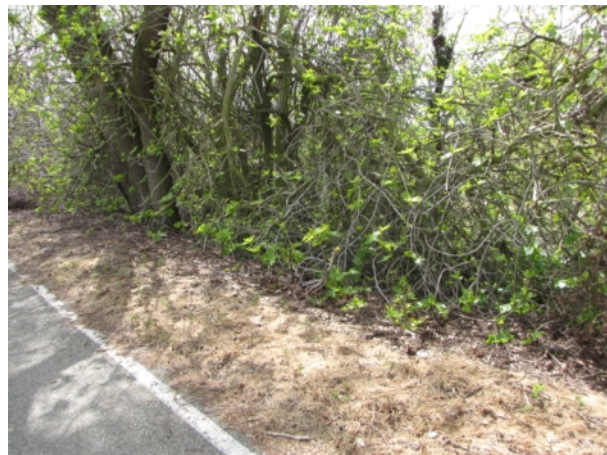
Levee Mile Report Line	4
Start Levee Mile	0.05
End Levee Mile	0.06
Location	Land Side
Category	Earthen Levee
Item	Trim / Thin Trees

Photo show wild growth of fog trees on shoulder and slope of levee, not able to see the levee slope at all. Photo taken 11-03-2010

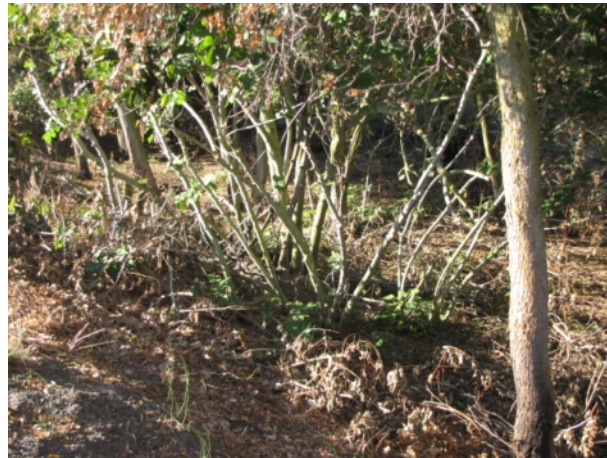
Levee Mile Report Line	5
Start Levee Mile	0.13
End Levee Mile	0.24
Location	Land Side
Category	Earthen Levee
Item	Trim / Thin Trees

Levee mile 0.13: District need to remove the Fig trees from levee section on the land side, not trim them up like shown in this photo. All these shown here are less than 2-inches in diameter.

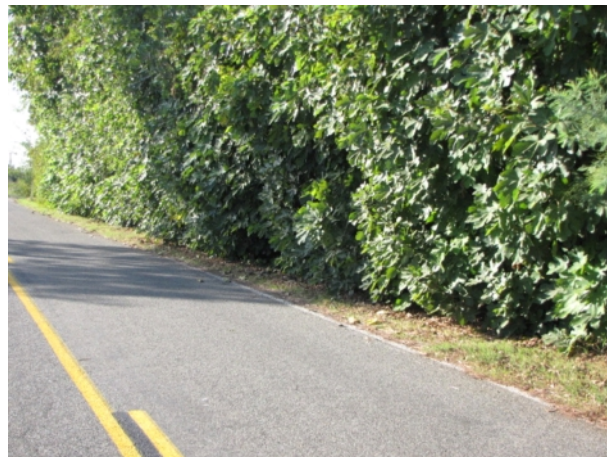
Levee Mile Report Line	7
Start Levee Mile	0.26
End Levee Mile	0.28
Location	Land Side
Category	Earthen Levee
Item	Trim / Thin Trees

This is a view of unsatisfactory Fig growth on the levee section land side looking downstream from levee mile 0.26 to 0.28. This photo was taken 11-03-2010 No change since last inspection.

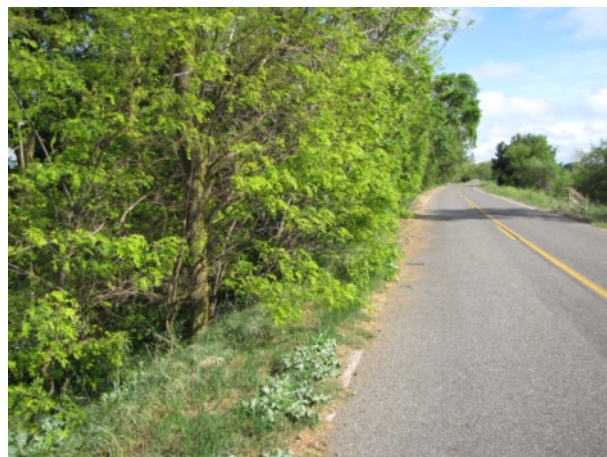
Levee Mile Report Line	7
Start Levee Mile	0.26
End Levee Mile	0.28
Location	Land Side
Category	Earthen Levee
Item	Trim / Thin Trees

New photo of unsatisfactory tree growth on levee miles 0.26-0.28 looking upstream from the landside shoulder. Photo taken 4-19-11.

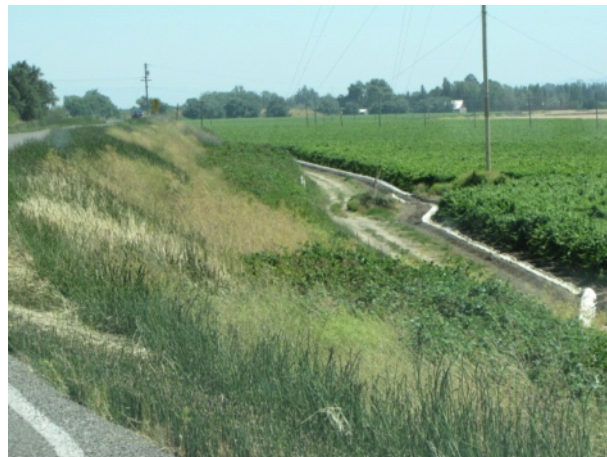
Levee Mile Report Line	22
Start Levee Mile	1.55
End Levee Mile	1.74
Location	Land Side
Category	Earthen Levee
Item	Vegetation

Levee mile 1.55 looking downstream landside slope is covered with wild berries. Taken 11-03-2010

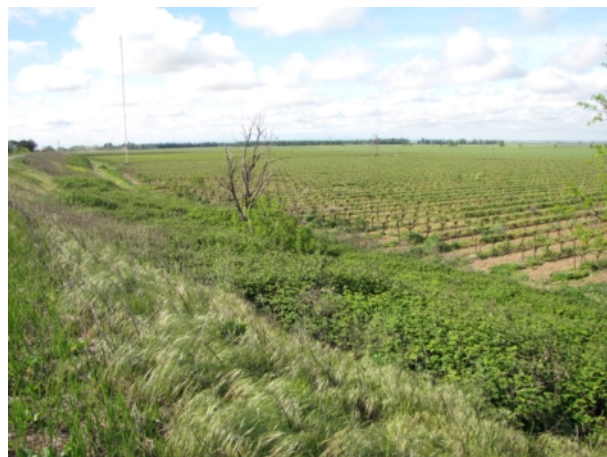
Levee Mile Report Line	22
Start Levee Mile	1.55
End Levee Mile	1.74
Location	Land Side
Category	Earthen Levee
Item	Vegetation

New photo of unsatisfactory growth at levee mile 1.55 looking downstream to levee mile 1.74 landside Unit 1. Photo taken 4-19-11.

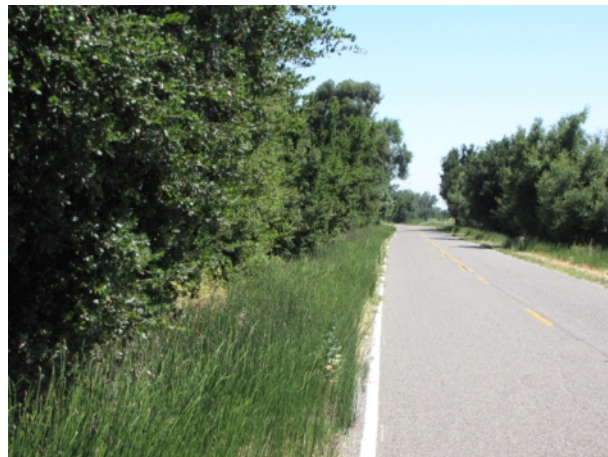
Levee Mile Report Line	34
Start Levee Mile	3.34
End Levee Mile	3.36
Location	Land Side
Category	Earthen Levee
Item	Trim / Thin Trees

Wild growth of trees on the landward shoulder and slope on levee. Standing at levee mile 3.34 looking downstream to levee mile 3.36.

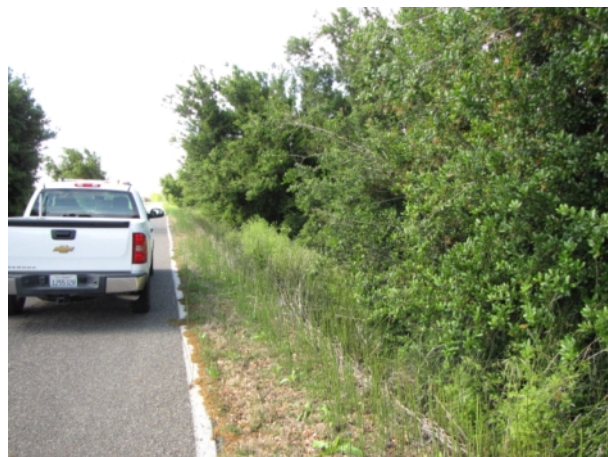
Levee Mile Report Line	34
Start Levee Mile	3.34
End Levee Mile	3.36
Location	Land Side
Category	Earthen Levee
Item	Trim / Thin Trees

Standing on levee mile 3.34 looking downstream towards levee mile 3.36 landward of Unit 1 RD 501 at the unsatisfactory wild growth on the levee slope. Photo taken 4-19-11

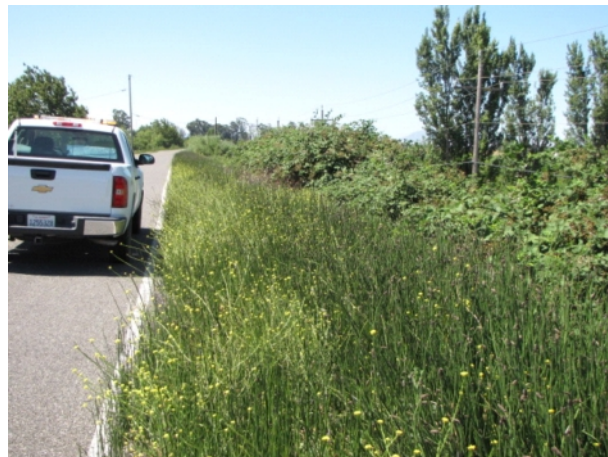
Levee Mile Report Line	42
Start Levee Mile	3.80
End Levee Mile	4.14
Location	Land Side
Category	Earthen Levee
Item	Vegetation

This section here shows that the berry vines are taller than the cab of the truck, you can't see the slope or toe because of the wild growth.

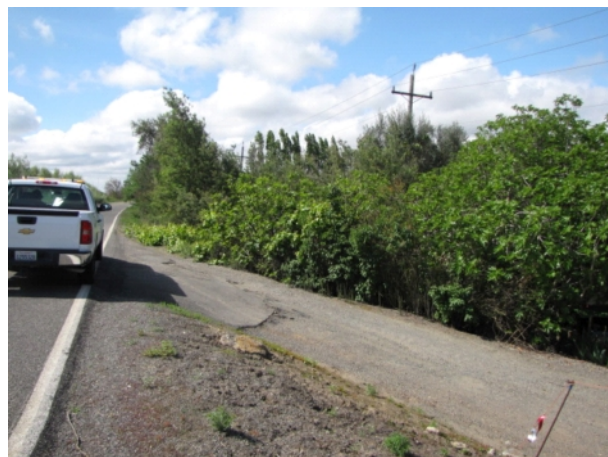
Levee Mile Report Line	42
Start Levee Mile	3.80
End Levee Mile	4.14
Location	Land Side
Category	Earthen Levee
Item	Vegetation

New photo of unsatisfactory growth landward levee mile 3.80-4.14 photo taken 4-19-11.

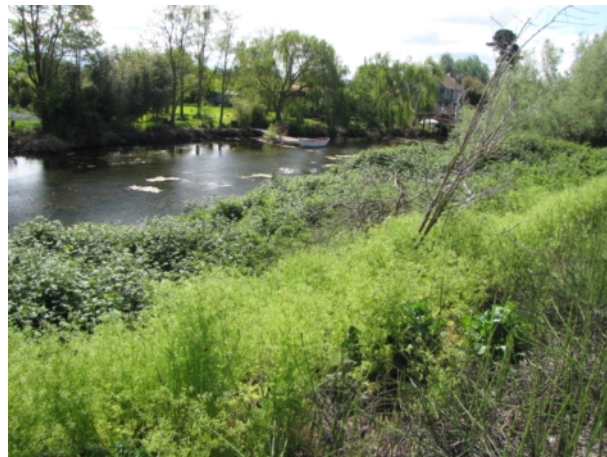
Levee Mile Report Line	43
Start Levee Mile	4.00
End Levee Mile	4.07
Location	Water Side
Category	Earthen Levee
Item	Vegetation

Looking downstream at waterside unsatisfactory growth on the levee slope. No change from fall inspection. Photo taken 4-19-11.

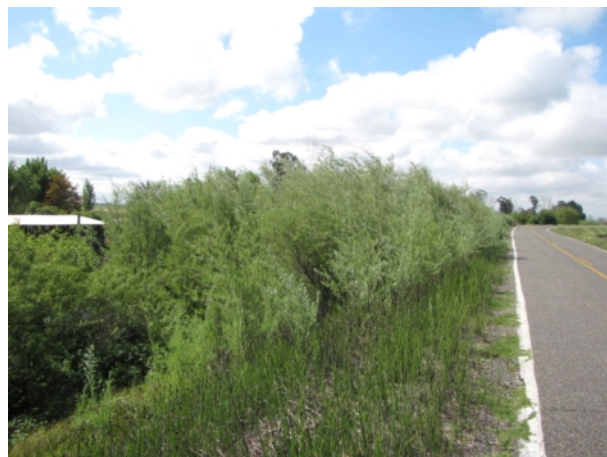
Levee Mile Report Line	44
Start Levee Mile	4.07
End Levee Mile	4.08
Location	Water Side
Category	Earthen Levee
Item	Vegetation

Looking downstream of levee mile 4.07 RD 501 at the unsatisfactory growth on waterside slope and shoulder. This photo was taken 4-19-2011

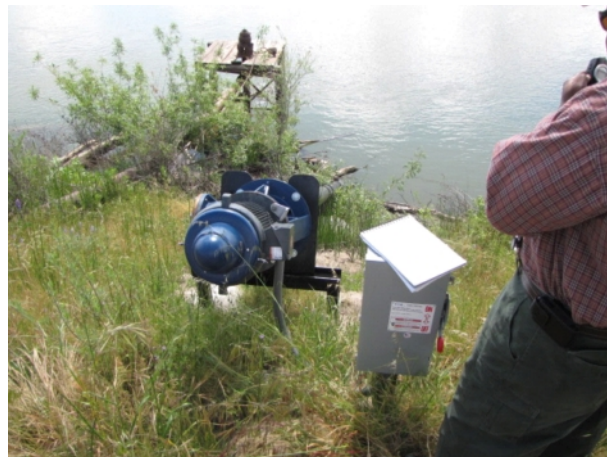
Levee Mile Report Line	53
Start Levee Mile	5.93
End Levee Mile	5.93
Location	Water Side
Category	Earthen Levee
Item	Encroachments

Another view of the unauthorized pipe. At levee mile 5.93. Unit 1 RD 501. Photo taken 4-19-11.

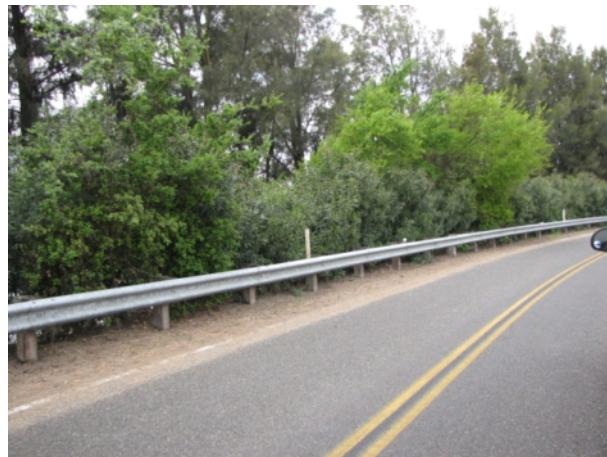
Levee Mile Report Line	2
Start Levee Mile	0.00
End Levee Mile	0.00
Location	Water Side
Category	Earthen Levee
Item	Vegetation

New photo of waterside looking downstream from levee mile 0.00. Photo taken 4-19-11.

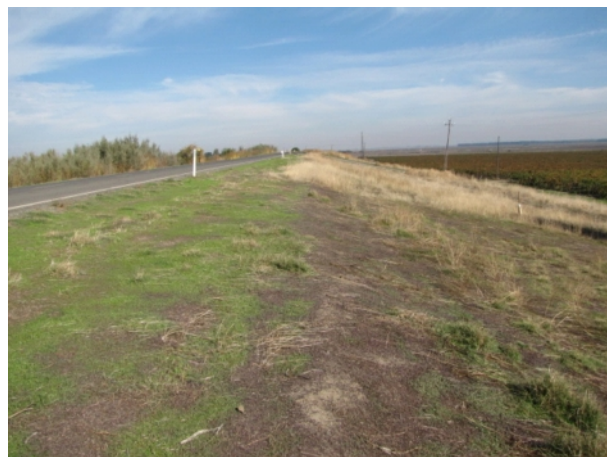
Levee Mile Report Line	5
Start Levee Mile	0.44
End Levee Mile	0.44
Location	Land Side
Category	Earthen Levee
Item	Vegetation

Standing on land side looking down stream from levee mile 0.44 RD 501 Unit 2. Taken 11-03-2010

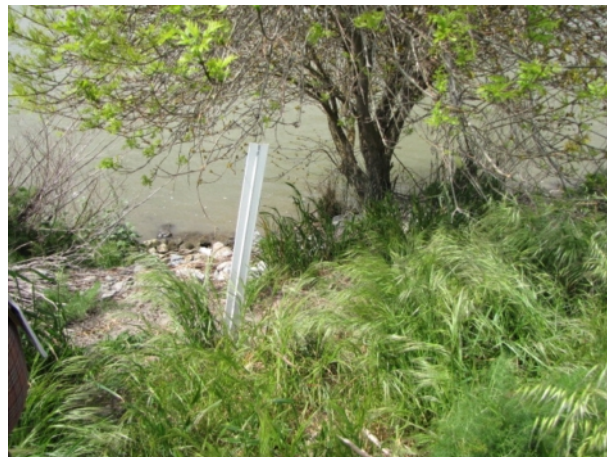
Levee Mile Report Line	7
Start Levee Mile	1.03
End Levee Mile	1.03
Location	Water Side
Category	Earthen Levee
Item	Erosion / Bank Caving

Down at the base of the tree and the stake in view is bank erosion. This site was discovered 2-11 by Resident of the Hester property on the landside of the levee. The District has placed material in the eroded area however more is needed. Photo was taken 4-19-11.

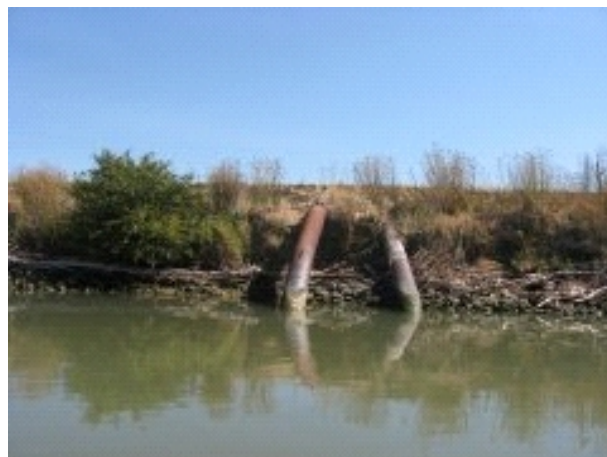
Levee Mile Report Line	9
Start Levee Mile	1.13
End Levee Mile	1.17
Location	Water Side
Category	Supplemental
Item	USACE Erosion Survey

2009: 3 ft berm, 2:1 slope, holes and slumping, clays and cobbles, 10.9 ft/s [2009 SiteID:CHS\_15-9\_L]

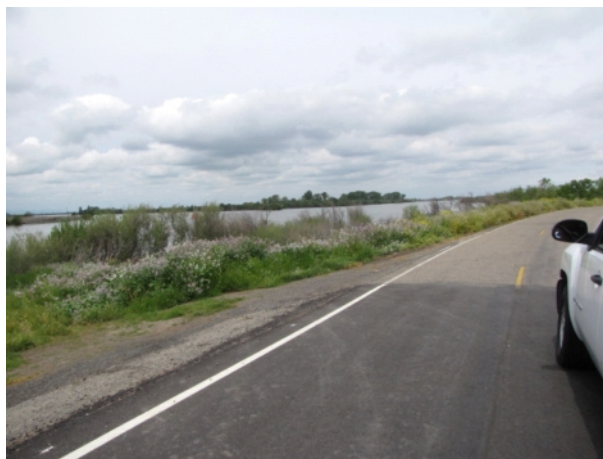
Levee Mile Report Line	2
Start Levee Mile	0.00
End Levee Mile	0.00
Location	Water Side
Category	Earthen Levee
Item	Vegetation

New photo of waterside levee mile 0.00 looking downstream. Photo taken 4-19-11.

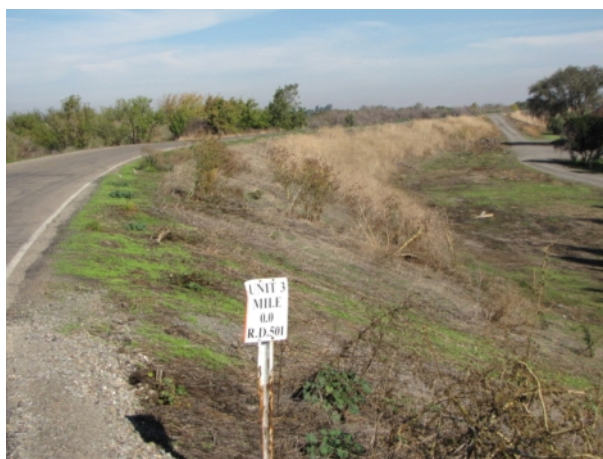
Levee Mile Report Line	3
Start Levee Mile	0.00
End Levee Mile	0.00
Location	Land Side
Category	Earthen Levee
Item	Vegetation

Levee mile 0.00 Unit 3 looking downstream on land side. Taken 11-03-2010

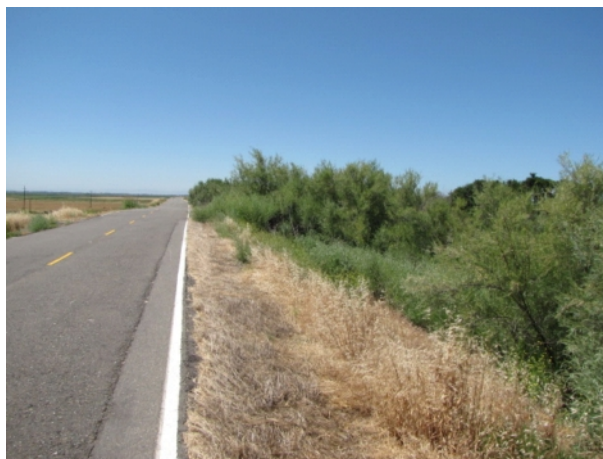
Levee Mile Report Line	7
Start Levee Mile	2.65
End Levee Mile	2.77
Location	Water Side
Category	Earthen Levee
Item	Trim / Thin Trees

2.65 looking upstream from downstream end  
waterside.

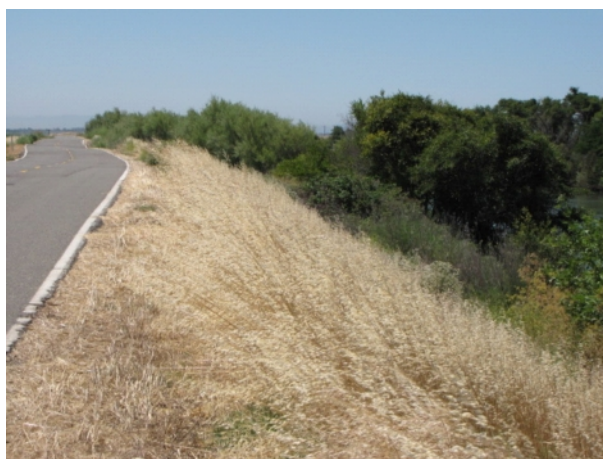
Levee Mile Report Line	7
Start Levee Mile	2.65
End Levee Mile	2.77
Location	Water Side
Category	Earthen Levee
Item	Trim / Thin Trees

Looking upstream from levee mile 2.77.

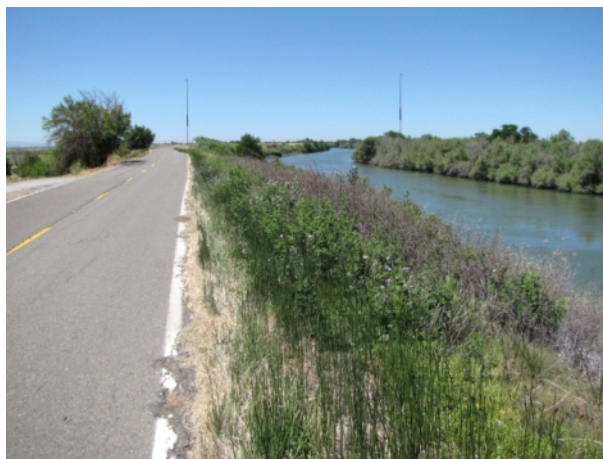
Levee Mile Report Line	8
Start Levee Mile	3.52
End Levee Mile	3.55
Location	Water Side
Category	Earthen Levee
Item	Trim / Thin Trees

Levee mile 3.52 standing on waterside looking upstream wild growth. Photo taken 11-03-2010

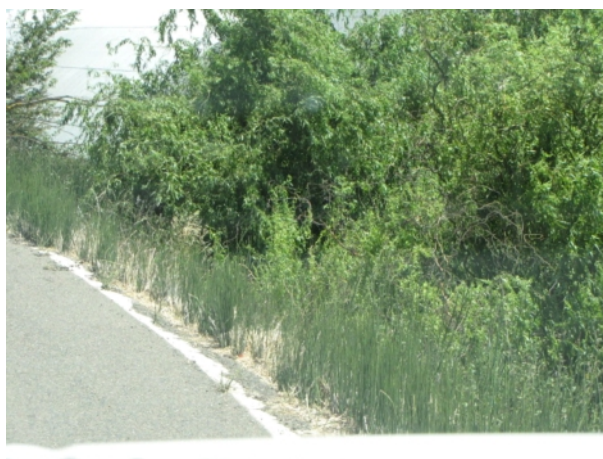
Levee Mile Report Line	8
Start Levee Mile	3.52
End Levee Mile	3.55
Location	Water Side
Category	Earthen Levee
Item	Trim / Thin Trees

Levee mile 3.55 land side tree growth on slope, you can't see the slope for wild growth. These trees has not been trimmed. Photo taken 11-03-2010

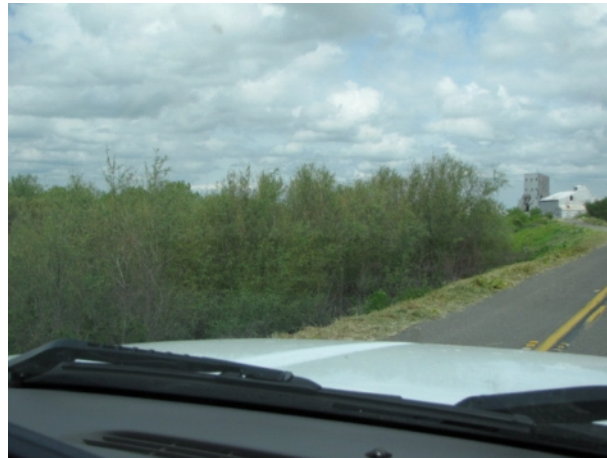
Levee Mile Report Line	8
Start Levee Mile	3.52
End Levee Mile	3.55
Location	Water Side
Category	Earthen Levee
Item	Trim / Thin Trees
New photo of waterside levee mile 3.52 to 3.55 looking downstream. Photo taken 4-19-11.	
phillips_s_20110427_282.jpg

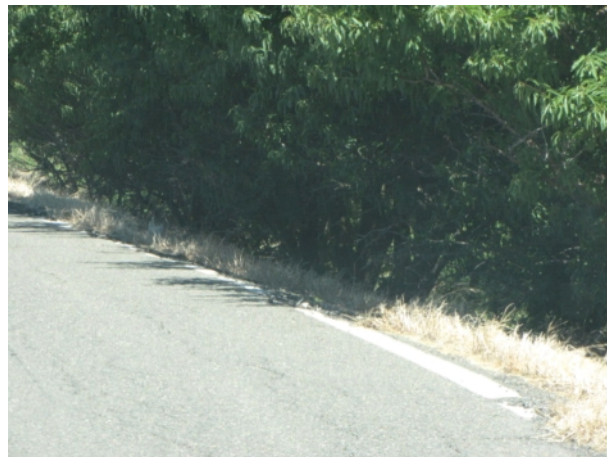
Levee Mile Report Line	10
Start Levee Mile	3.69
End Levee Mile	3.70
Location	Land Side
Category	Earthen Levee
Item	Trim / Thin Trees
Levee mile 3.69 tree growth has blocked view of levee on the land side.	
phillips_s_20110228_075.jpg

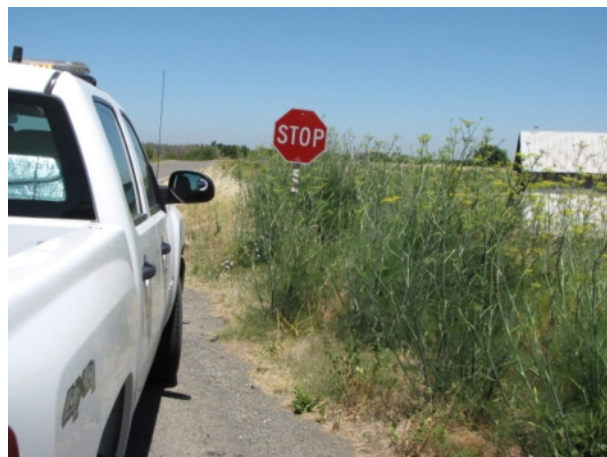
Levee Mile Report Line	10
Start Levee Mile	3.69
End Levee Mile	3.70
Location	Land Side
Category	Earthen Levee
Item	Trim / Thin Trees
Looking downstream from 3.70 tall growth continues down stream from this point. Taken 11-03-2010	
phillips_s_20110228_076.jpg

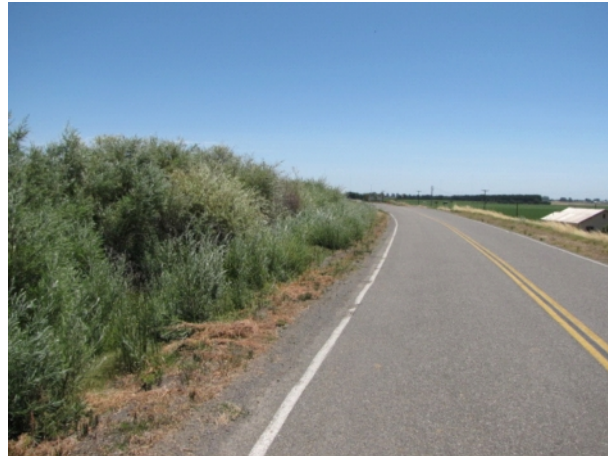
Levee Mile Report Line	14
Start Levee Mile	6.43
End Levee Mile	6.52
Location	Water Side
Category	Earthen Levee
Item	Trim / Thin Trees

Levee mile 6.43 water side the wild growth blocks view of water ward slope, looking downstream. You can't see the levee section for the wild growth.

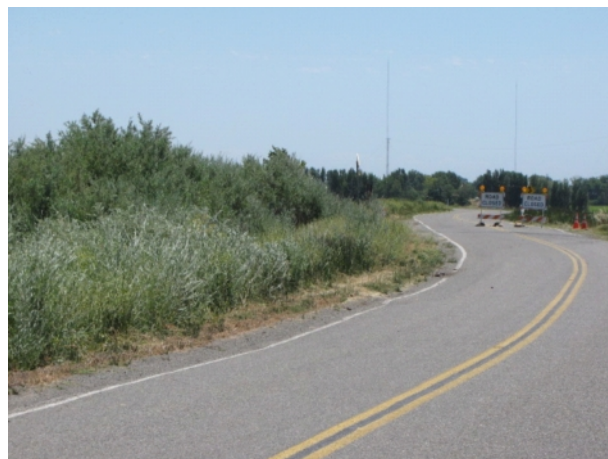
Levee Mile Report Line	14
Start Levee Mile	6.43
End Levee Mile	6.52
Location	Water Side
Category	Earthen Levee
Item	Trim / Thin Trees

Wild growth continues downstream, levee section blocked by growth.

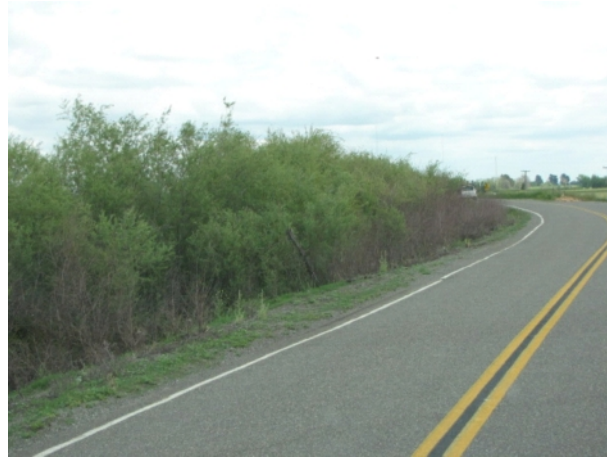
Levee Mile Report Line	14
Start Levee Mile	6.43
End Levee Mile	6.52
Location	Water Side
Category	Earthen Levee
Item	Trim / Thin Trees
New photo of waterside unsatisfactory growth levee mile 6.43 to 6.55 looking downstream. Photo taken 4-19-11.	
phillips_s_20110427_284.jpg

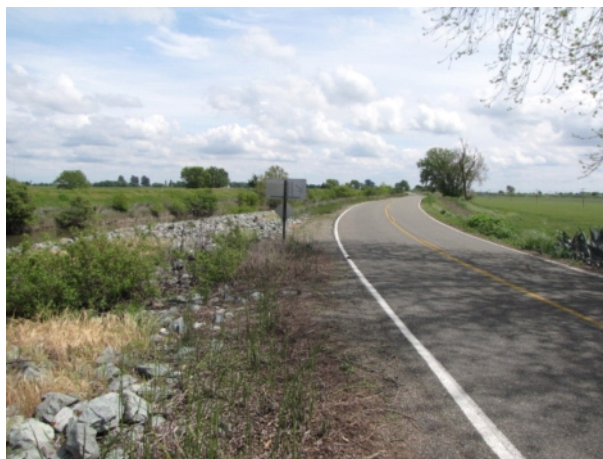
Levee Mile Report Line	2
Start Levee Mile	0.00
End Levee Mile	0.00
Location	Water Side
Category	Earthen Levee
Item	Vegetation

Standing on the waterside levee mile 0.00 Unit 4 RD 501 looking downstream. Photo taken 4-19-11

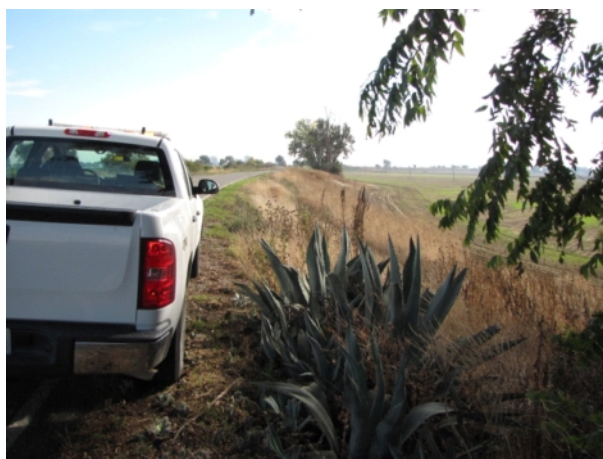
Levee Mile Report Line	3
Start Levee Mile	0.00
End Levee Mile	0.00
Location	Land Side
Category	Earthen Levee
Item	Vegetation

Standing upstream of levee mile 0.00 landside looking downstream of Unit 4 RD 501. Photo taken 11-04-2010
